Snobs Creek Water Quality Monitoring Report.

Rainfall Event 1-5-19 to 3-5-19

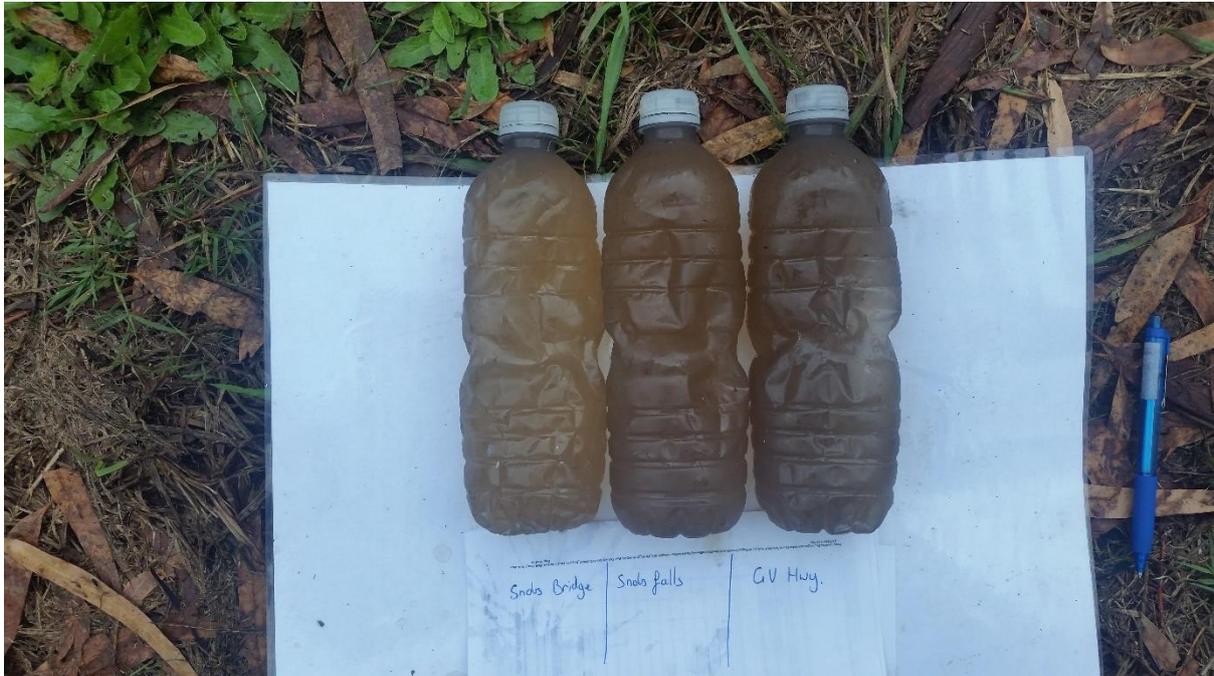
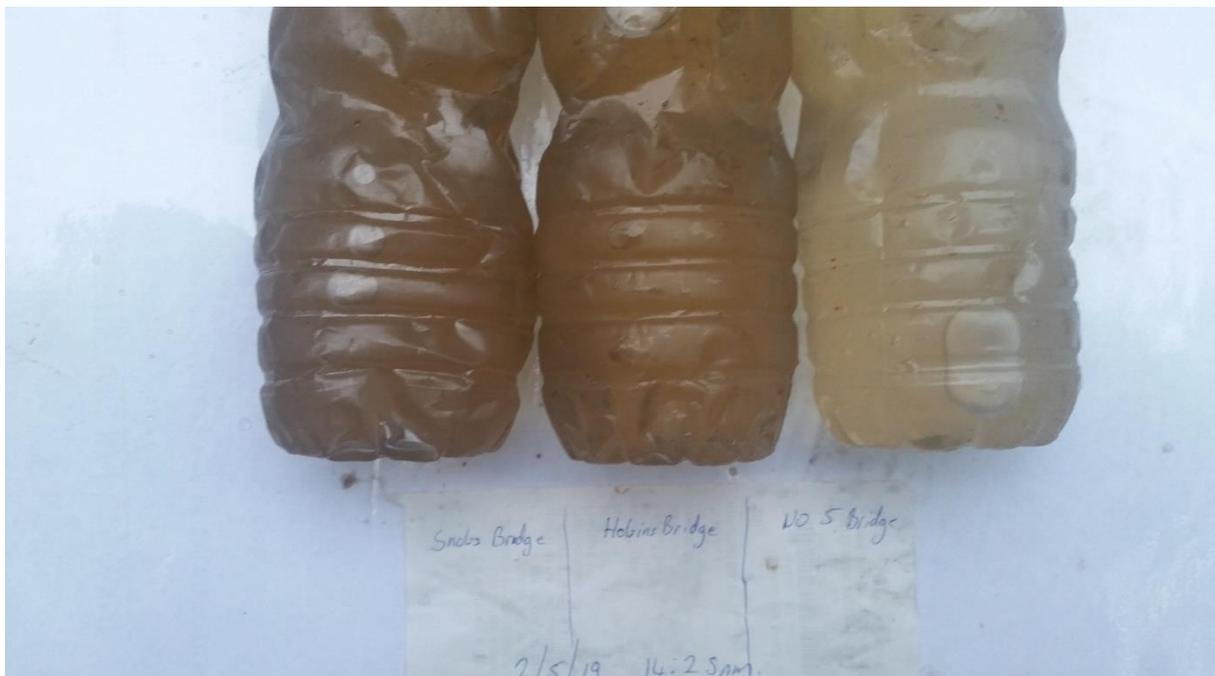
Snobs Creek area visited in the afternoon, light rain falling and road gutters flowing water 45mm of rain had fallen by this stage. Snobs Creeks level had increased. Water quality was lowest at the Goulburn Valley Highway and steadily improved to the highest point in the catchment inspected at the Number 5 Bridge on the Number 5 Track.

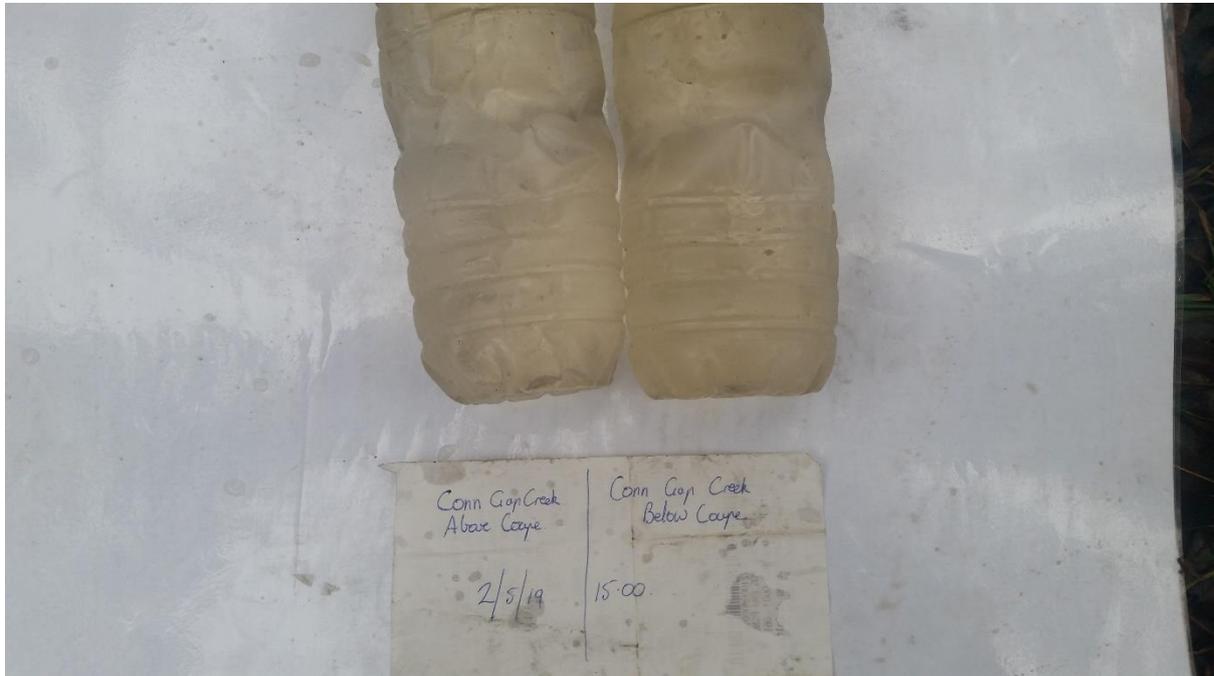
The small stream adjacent to Snobs 14 harvesting coupe was also inspected, In the upper catchment above Conn Gap Bridge and directly below the coupe on Snobs Creek Road. This creek was referred to at Conn Gap Creek in the photos but was later identified on maps as Mill Creek. Water quality only decreased slightly from the upper catchment to below the harvesting Coupe.

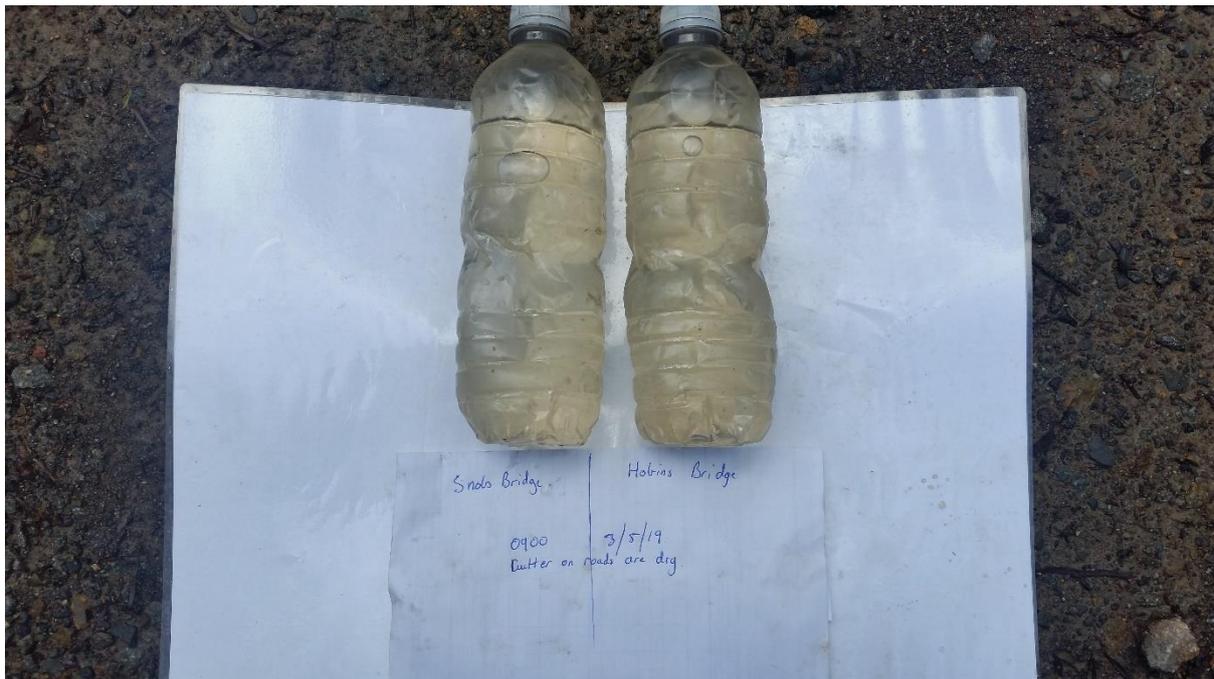
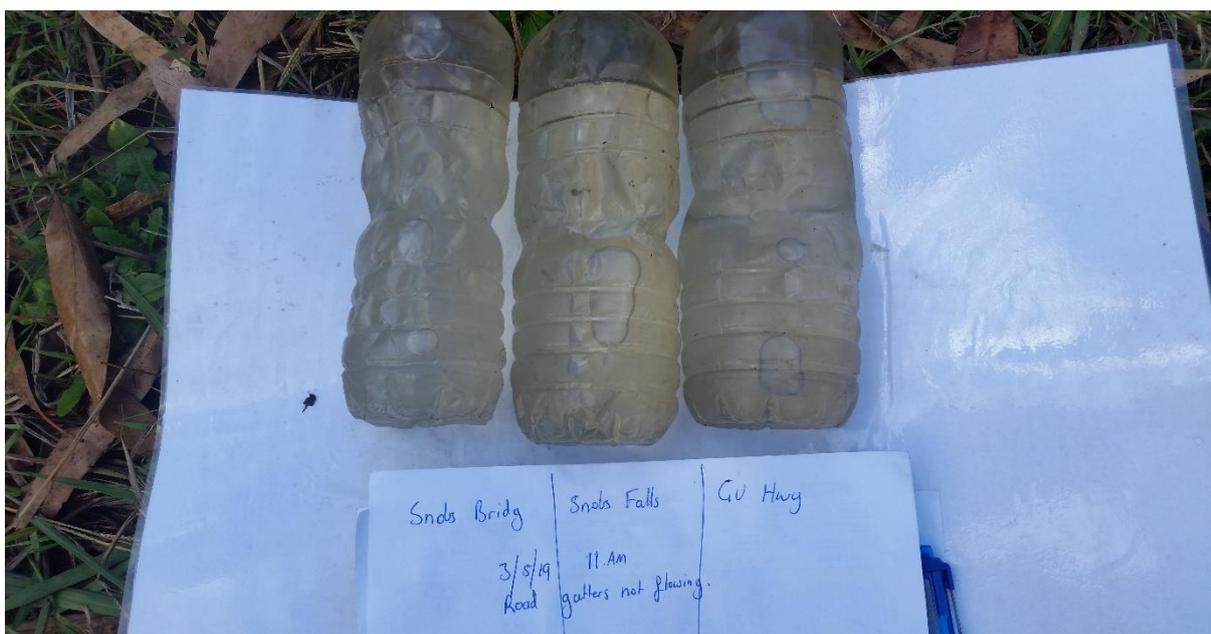
Due to the poor quality of the water found in the Snobs Creek catchment the previous day and the high intensity rainfall that fell after 5pm a second visit occurred in the morning of the 3-5-19. It had stopped raining by this stage and the rain gauge at Snobs 14 showed that another 16mm had fallen, totalling 60mm since the start of the rain event. The road gutters had stopped flowing and were mostly dry. The level of Snobs Creek had dropped and water quality had significantly improved from the day before when road gutter were flowing. Water quality had no visible decline in quality from the upper catchment to the lower catchment.

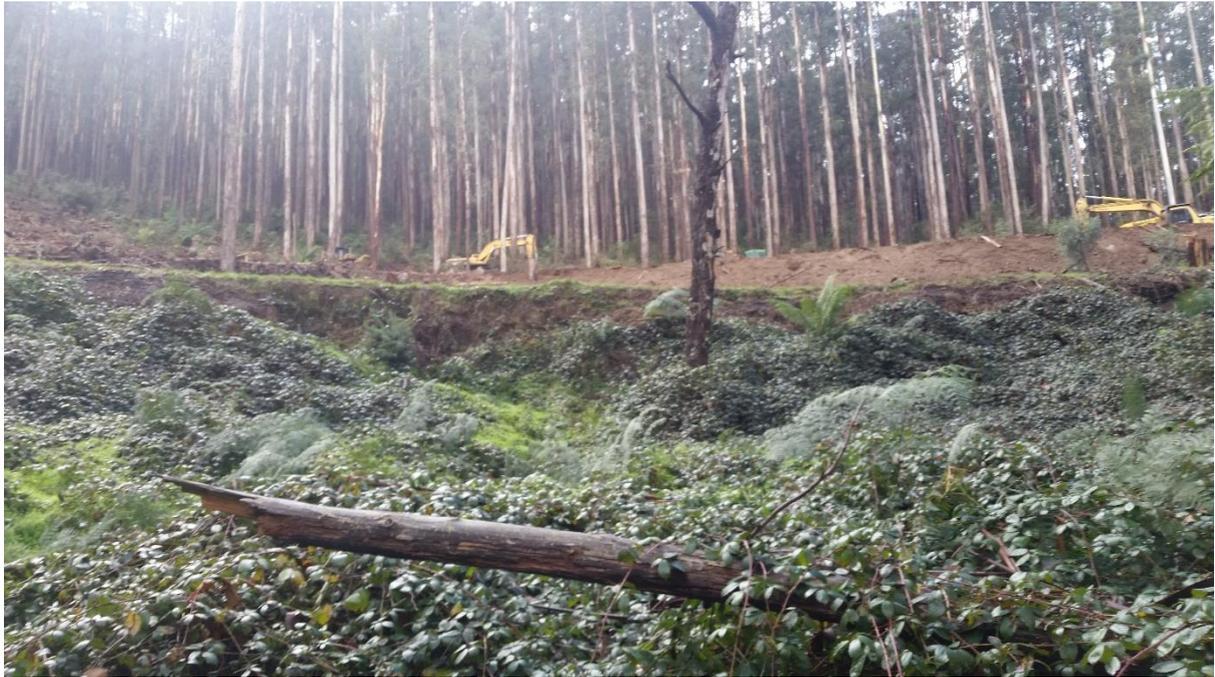
The heavy rainfall the night before had caused significant runoff from the landing, this water is filtered by the sediment traps and is directed into a road culvert directly below the Snobs 14 landing. Below the road was inspected to determine if any of the water from the landing had flowed directly into Snobs Creek. The area below the road is infested with blackberries and the outlet of the culvert couldn't be found. The drainage line was followed until running water was found, this was then followed until it entered Snobs Creek itself. No evidence of sediment from the Snobs 13 Snobs 14 harvesting coupe was found below Snobs Creek Rd. No evidence of sediment laden water from the coupe entering Snobs Creek or Mill Creek. See Video evidence attached to Email.

Recommend that further inspections of water quality been done in the Snobs Creek Catchment when high rainfall events are forecast. Continue to inspect the sediment traps on Snobs 13 and Snobs 14 coupes, dig out sediment traps when full, monitor landing for any emerging issues. Continue to report to Delwp when road network drainage structures require maintenance. Continue to monitor weather and road conditions for the suitability of harvest and haulage operations
